THE CASE OF THE
METHODIST CHAPEL FAILURE

Human errors caused the collapse of this beautiful \$83,000 chapel. These errors were made by the architect, engineer, general contractor and sub-contractor, all of whom suffered financial loss as a result. Study of this case is especially appropriate for courses in civil engineering structural analysis and design.

© 1971 by the Board of Trustees of the Leland Stanford Junior University, Stanford, California. Prepared by Professor Paul H. Sanders, Georgia Institute of Technology. Published with the support of the National Science Foundation.

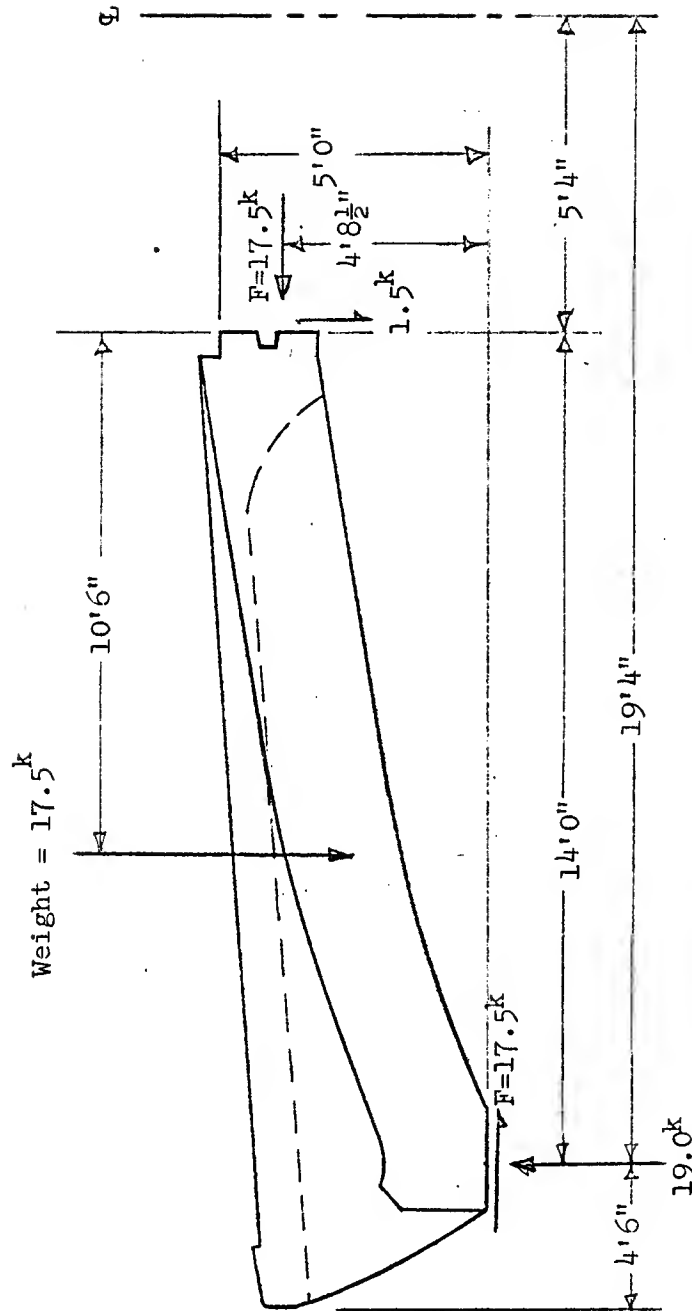
Figure 3

Dead Load Forces Acting on Typical Roof Segment

Since the web of the S8 x 18.4 is relatively thin (0.271 inches), it can be assumed that the force transmitted by it to the flange, in a horizontal direction perpendicular to the web, is negligible. Therefore, the normal force resisted by the weld in Figure 11 is calculated by (F from Figure 3)

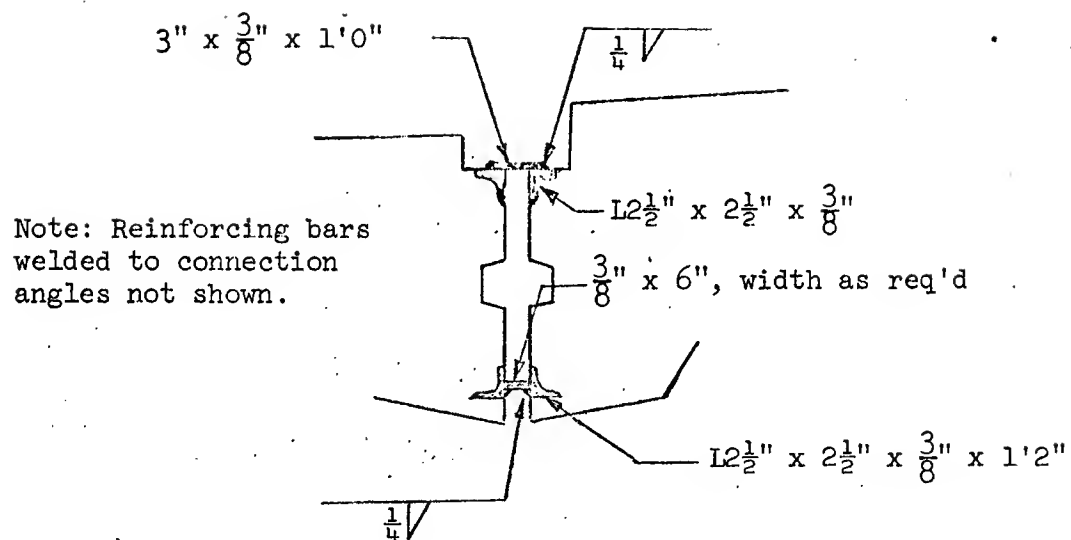
Figure 4b

* Compression Ring Connection Detail

This failure was caused by fracturing of the welds of the tension ring, which were later determined to have 30% average penetration, instead of 100% as intended by the structural engineer. As these welds parted, the top flanges of the tension ring moved outward, causing the roof segments to translate outward and rotate (clockwise on Figure 3). After some small displacement, the lower connections between roof segments and compression ring (Figure 4b) parted. At that point no moment resistance or arch action remained, and collapse ensued.

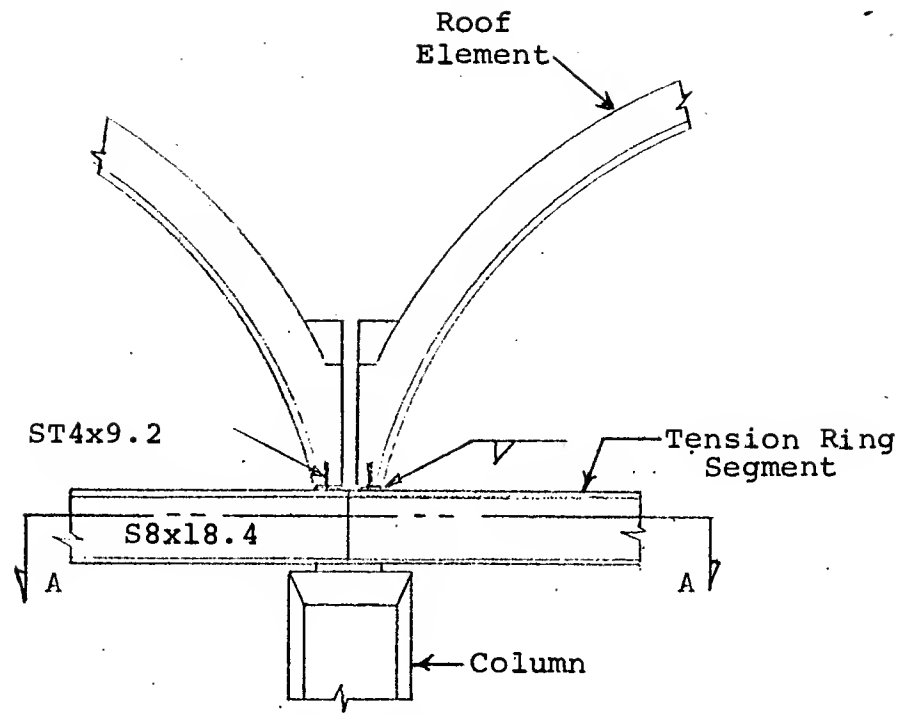
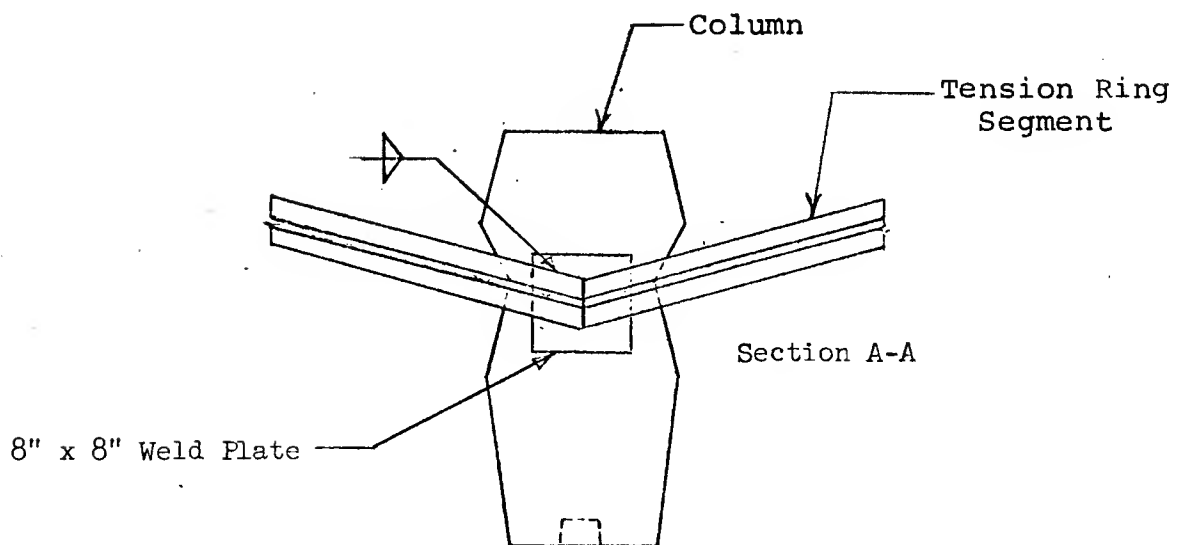
Typical Tension Ring Connection

The young civil engineer told his employer of his chance encounter with the structural engineer of the chapel, repeated the information he had received and observed, "In looking over the job it appeared that nearly all the tension ring welds had fractured. No metal fractures occurred at places other than welded joints. The welds were uneven and sloppy and the shop paint hadn't even been removed from the vicinity of the welds. I think the welds broke first, then the structure collapsed."

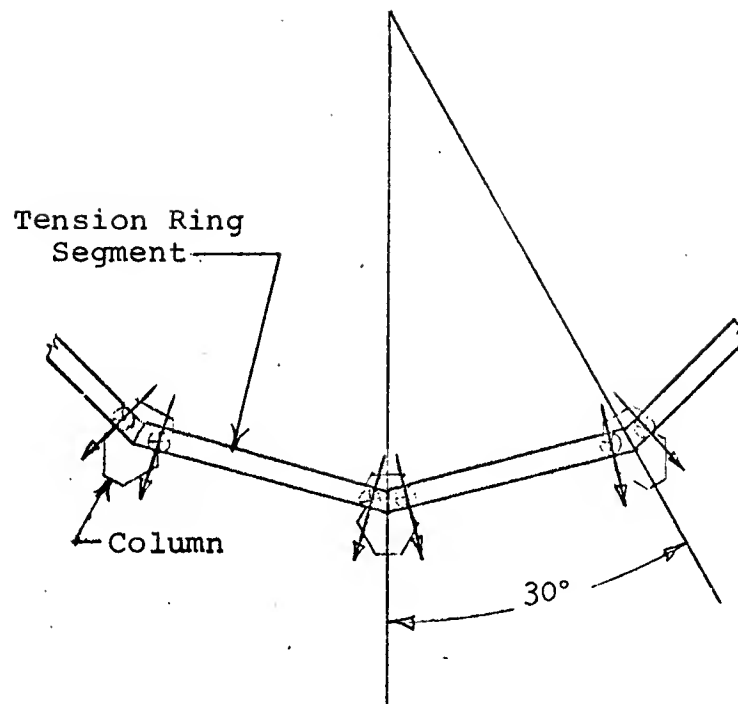
Figure 7

Plan View of Forces Acting on Top
Flange of Tension Ring
